Booster 15Hz Operation

John Reid

March 4, 2014

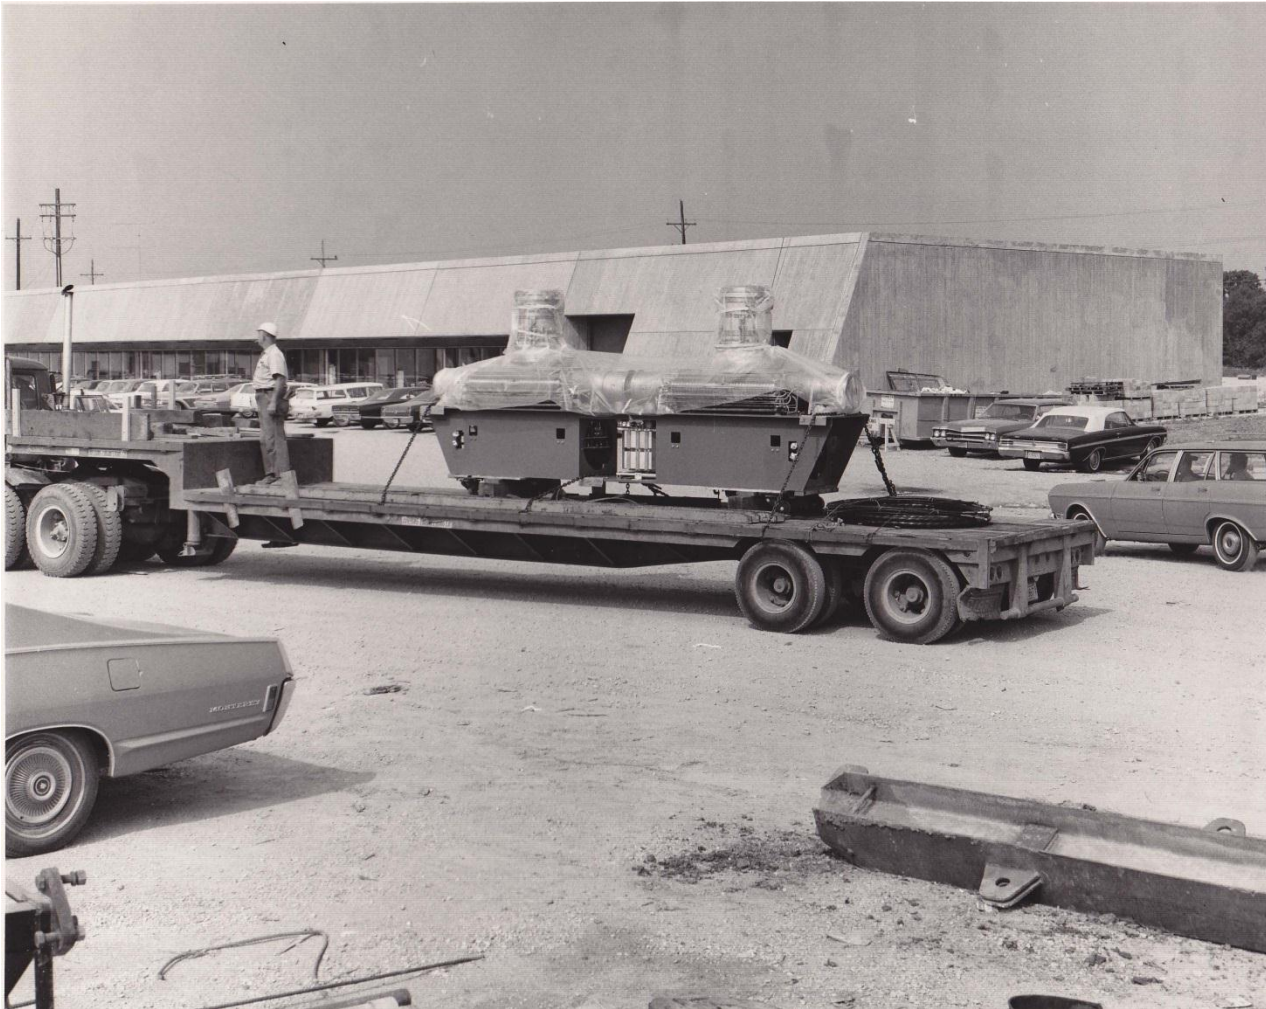
Booster RF Cavity Pair Delivery X-Gallery

July 1970
Flatbed semi
delivering
Booster RF
cavity pair
with original
one piece
girder to X-
Gallery.

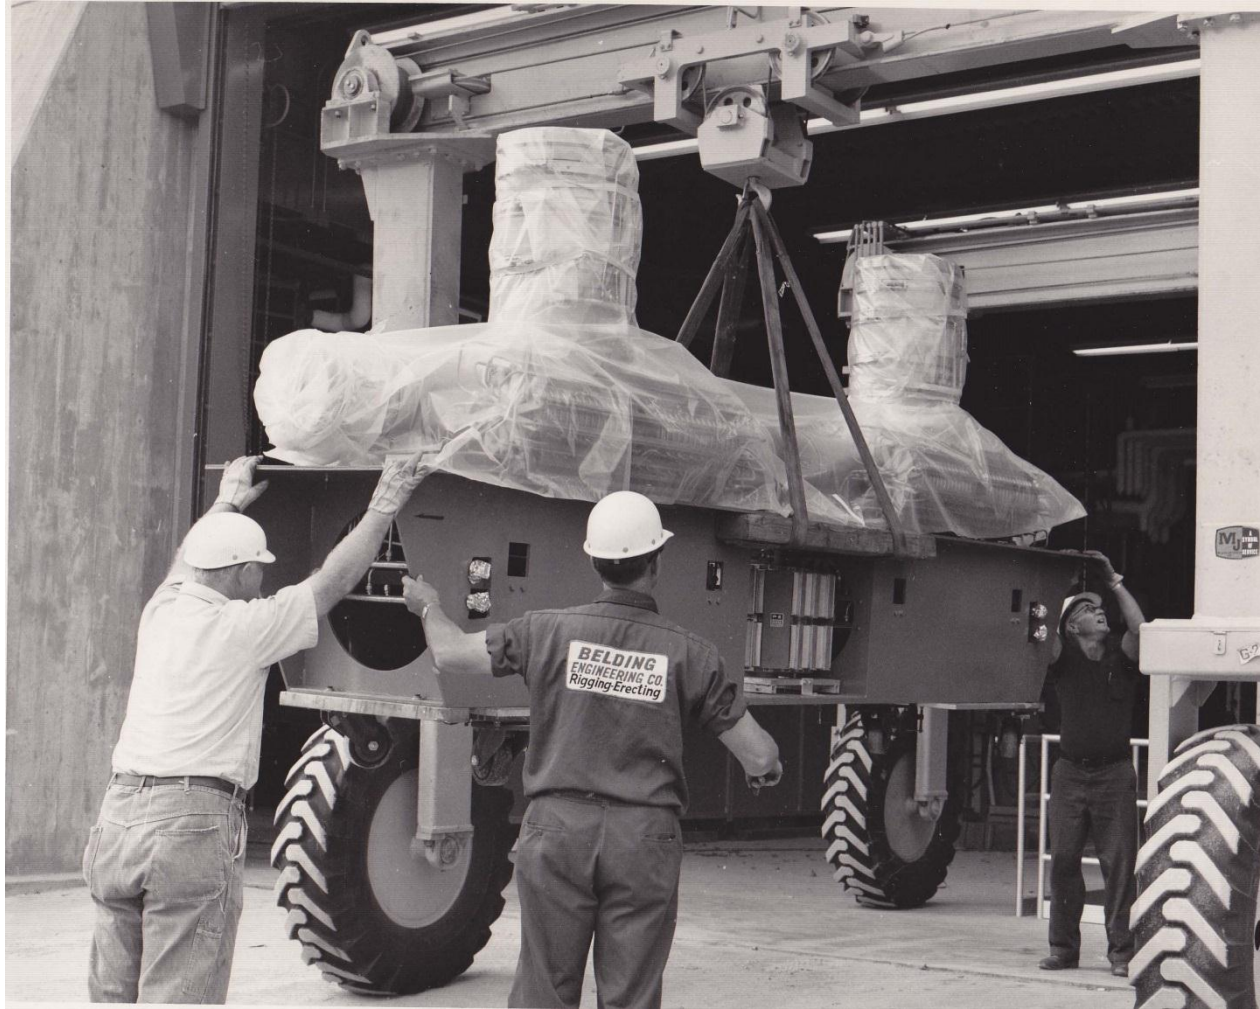
Booster RF Cavity Pair Delivery X-Gallery

July 1970 –
Single one
piece girder
with two RF
cavities at x-
gallery high-
bay – ready
to be lowered
into Booster
staging area.

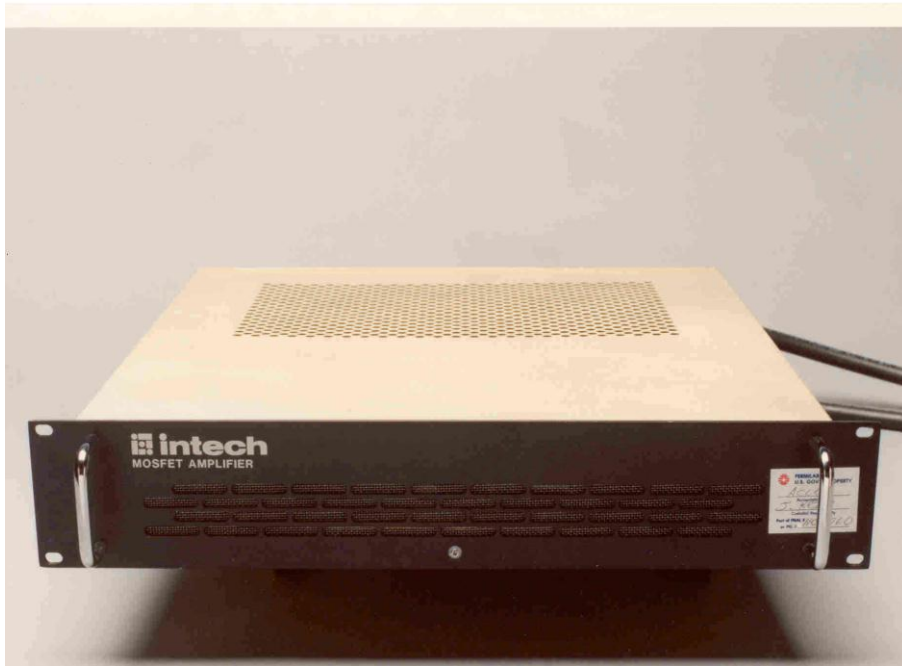
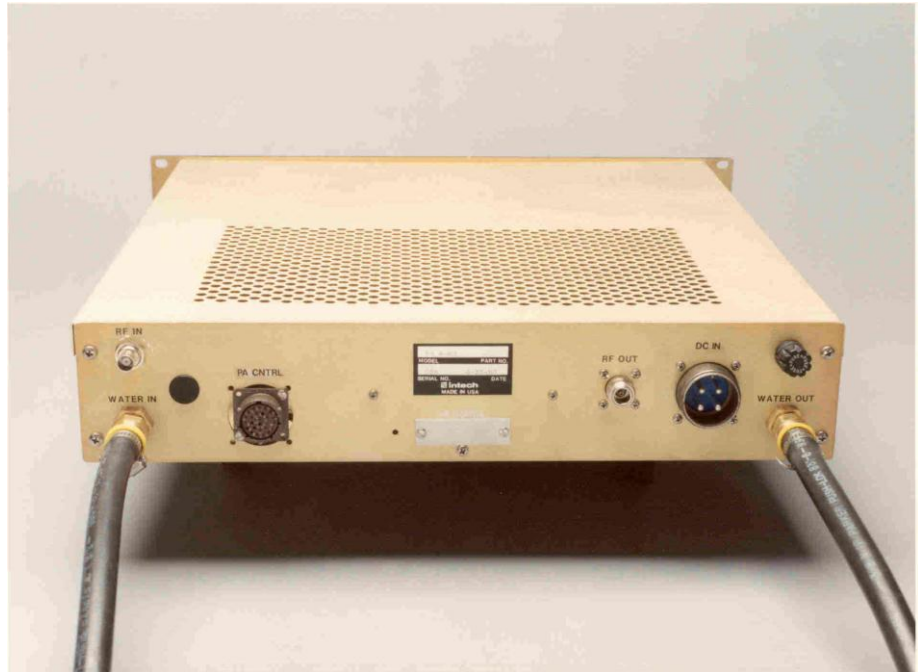
1 kWatt Solid State RF Module

- Build 22 new FNAL designed modulators (identical to MIRF).
- Build 22 new FNAL designed 150kW power amplifiers
- Build 22 new FNAL designed 4kW solid state driver amplifier assemblies.
- Replace all RF station cabling to the tunnel (HV, ½” Heliax,
- & all control cables.

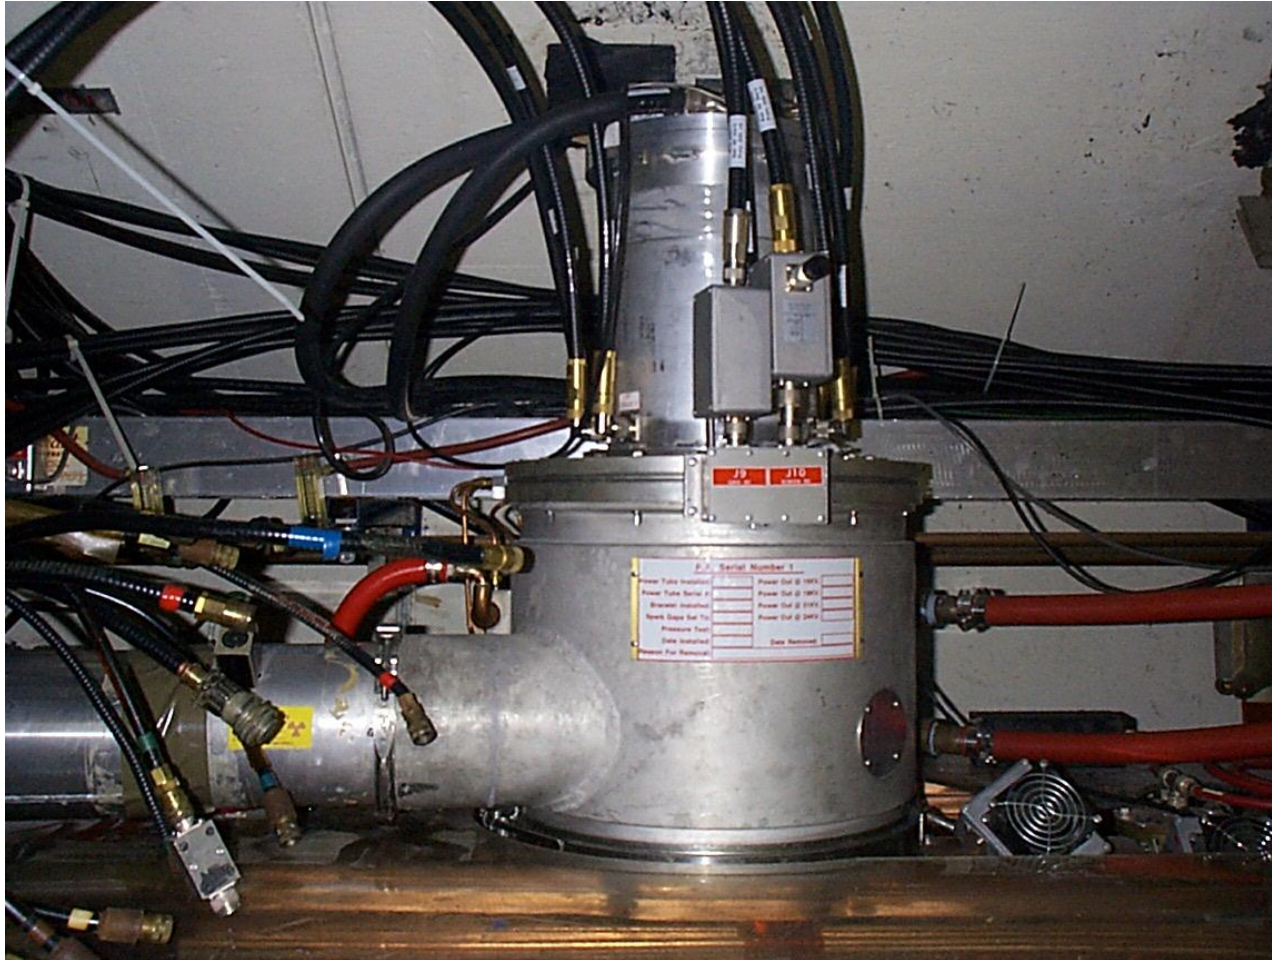
Booster St 12 Amplifier

New 150 kW
power amplifier
on station 12's
cavity

- 10 stations in the West Gallery run off one outdoor anode supply.
 - 9 stations in the East Gallery run off another outdoor anode supply.
- **All 19 stations are upgraded with 4kW Solid state driver assembly, new 30kV Series Tube Modulators, new 150 kW Power Amplifiers (St 12 upgraded in 2001 (prototype) and St 19 in 2005).**

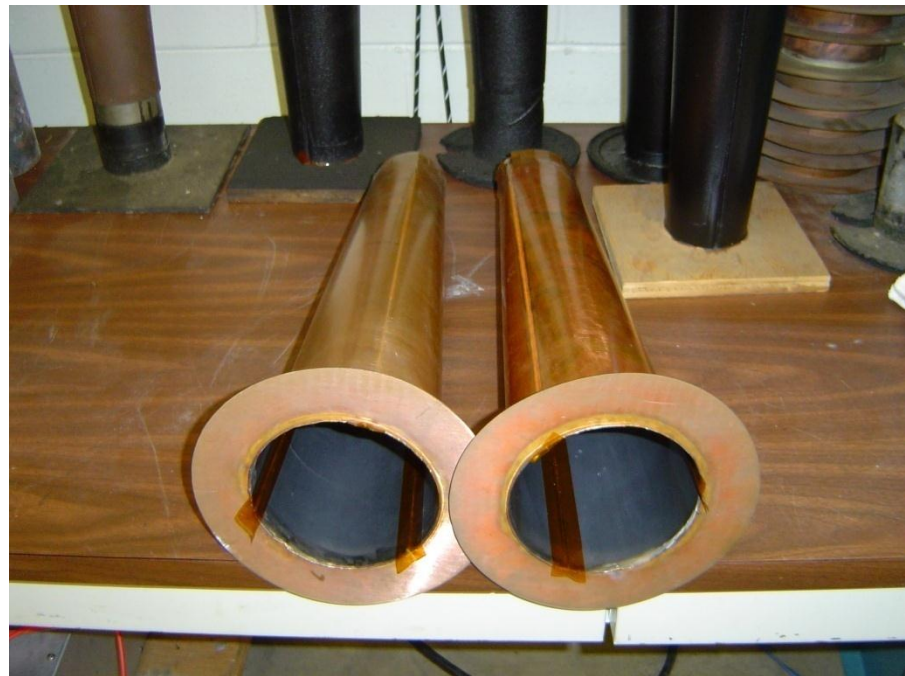
Bare copper castings
with single turn
cooling loop

5 mil Cu clad stainless skins

- **Required Modifications for 15Hz operation,**
 - Completed the Solid State Driver Upgrade project, March 2013.
 - Reconnect the ferrite cone cooling lines which were disconnected many years ago due to low duty factor operation.
 - Install new copper clad skins on tuner cone castings
 - Machine cavity tuner interface surfaces flat and parallel for good high power RF connections.
 - This requires removing cavities from tunnel and cycling tuners & cavities through a rebuilding process.
 - All cavities are run through the MI-60 test station and tested at a 15 Hz rate for a minimum of 168 hours of which 120 hours at full gradient before reinstallation in Booster tunnel.
- **Would like to have a second high power test stand at F0 to do long term testing of a refurbished cavity**
